# ES\_LPC43S5x/S3x Flash

## Errata sheet LPC43S5x/S3x flash-based devices

Rev. 1.4 — 24 September 2019

Errata sheet

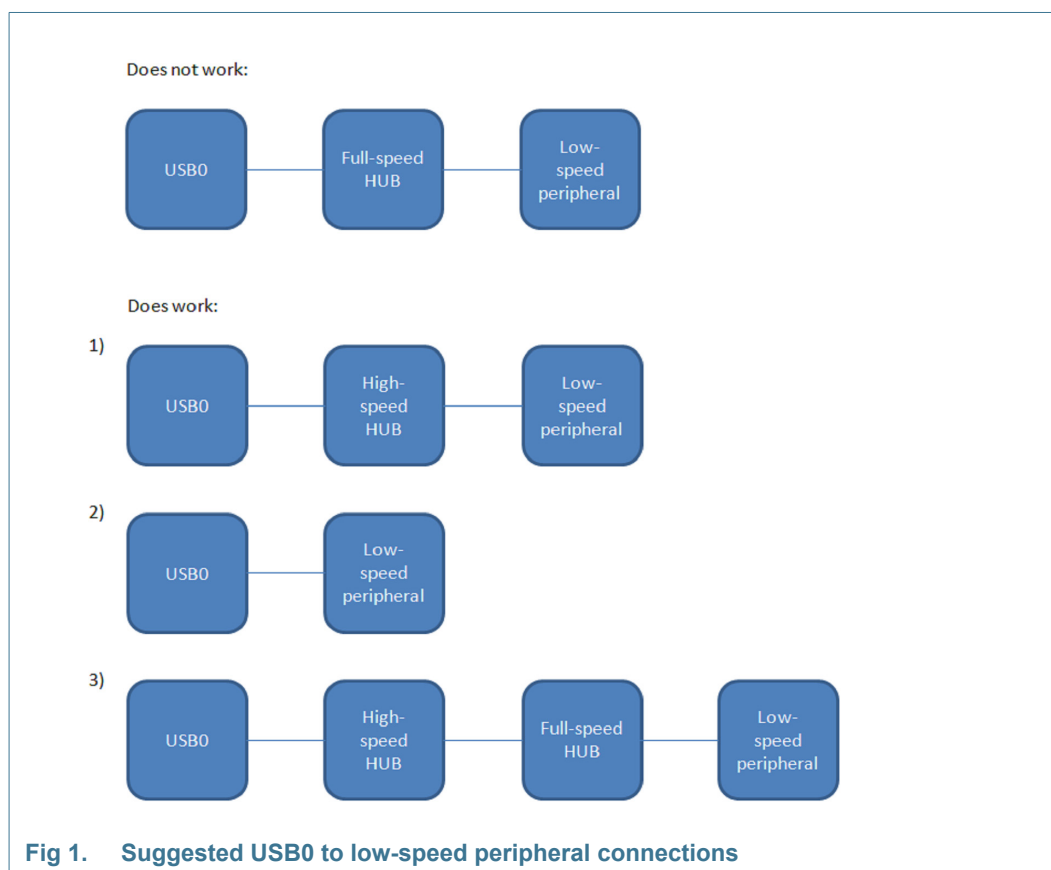
The USB controller called USB0 is unable to communicate with a low-speed USB peripheral in host mode when there is a full-speed hub directly connected to the USB0 port and a low-speed peripheral is connected in the tree somewhere below this full-speed hub. Only USB0 has this problem; the other USB controller, USB1 does not.

There is no work-around for this problem. It is suggested that the low-speed USB peripheral is either connected directly to USB0 or a high-speed hub is placed between that peripheral and USB0.
