# Chip Errata for the i.MX 6UltraLite

This document details the silicon errata known at the time of publication for the i.MX 6UltraLite multimedia applications processors.

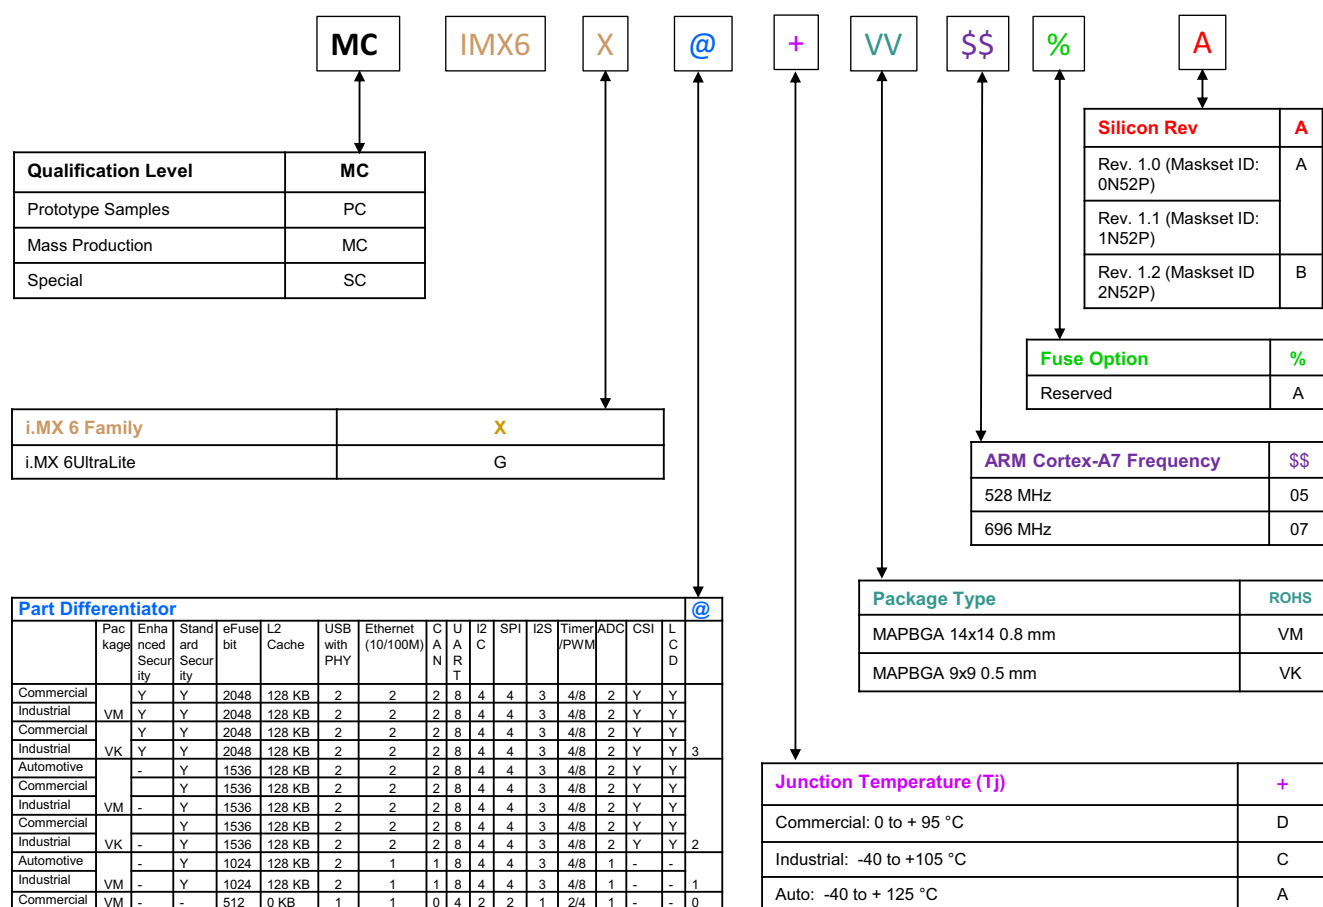
Figure 1. Revision Level to Part Marking Cross-Reference

Figure 1 provides a cross-reference to match the revision code to the revision level marked on the device.

| Rev. Number | Date | Substantive Changes |
|---|---|---|
| Rev. 2.2 | 05/2017 | <ul style="list-style-type: none"><li>Updated <a href="#">Figure 1</a>, "Revision Level to Part Marking Cross-Reference"</li><li>Updated the following Errata BSP status:<ul style="list-style-type: none"><li>– <a href="#">ERR005778</a></li><li>– <a href="#">ERR007265</a></li><li>– <a href="#">ERR010690</a></li></ul></li></ul> |

| Rev. Number | Date | Substantive Changes |
|---|---|---|
| Rev. 0.1 | 02/2016 | <ul style="list-style-type: none"><li>• Updated <a href="#">Figure 1, "Revision Level to Part Marking Cross-Reference"</a></li></ul> |
